TESTS ON 6 ¼ INCH METAL SPARS

Air Service Information Circular, Volume VII, No. 622

A.S. NILES, Jr.

August 15, 1928

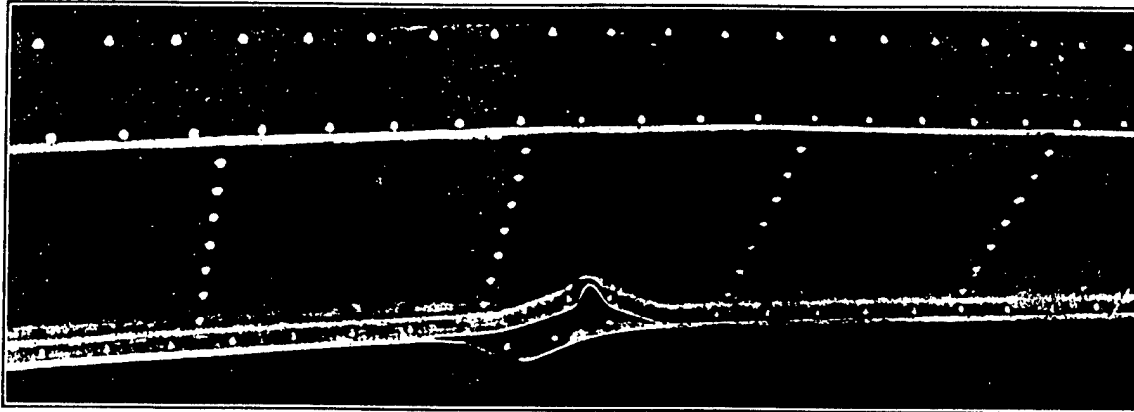
Fig. 18

102. The failures of 11 spars were due to the failures of connections between the parts forming the spars. These were the five spars of type 10, and 16G, 16H, 21A, 21B, 22A, and 22B. Seven of these spars were therefore boxes, and four were duralumin channel trusses. The spars of type 10 all failed in the same manner, some of the rivets joining the webs to the cover plates first failing in tension. This suddenly doubled the unsupported length of the cover plates which immediately became long slender columns subjected to a higher unit stress than they could carry with their new unsupported lengths and they immediately buckled. This kind of failure is shown clearly in Figure 18, a close-up of the failure of spar 10A. In type 21 the edges of the cover plates were turned
